AMMRC TR 79-12 BRITTLE MATERIALS DESIGN, HIGH TEMPERATURE GAS TURBINE

Arthur F. McLean, Ford Motor Company, Dearborn, Michigan 48121 John R. Secord, Ford Motor Company, Dearborn, Michigan 48121

Interim Report Number 14, September 30, 1977 to March 31, 1978

Contract Number DAAG 46-71-C-0162

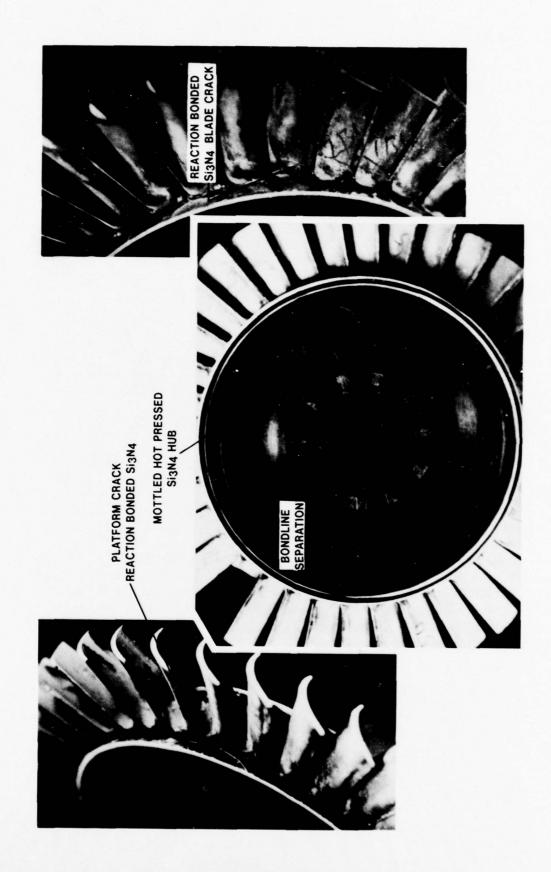
The fluorescent dye penetrant inspection reveals bonding defects, cracks induced during machining, high porosity regions, and mottling effects (13) in the hot pressed silicon nitride disk. Several of these defects are shown in Figure 3.4. The fluorescent dye penetrant technique is also useful in detecting blade root cracks which are difficult to observe under visual examination. Table 3.2 summarizes the results of this examination for the rotors currently through final machining.

Figure 3.4 — Examples of Turbine Rotor Defects Revealed by Zyglo. T.M. ROTOR 1355

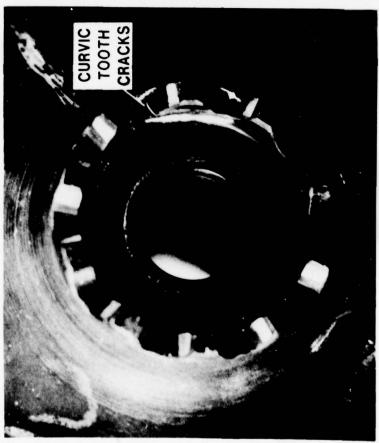
Figure 3.6 - Curvic Tooth Cracks Revealed by Zyglo. T.M.
